Oral Rehabilitation of a Young Female Patient with Severely Worn Dentition Using a Systemic Approach: A Case Report

Esthetics,
oral rehabilitation,
occlusion,
tooth wear,
vertical dimension

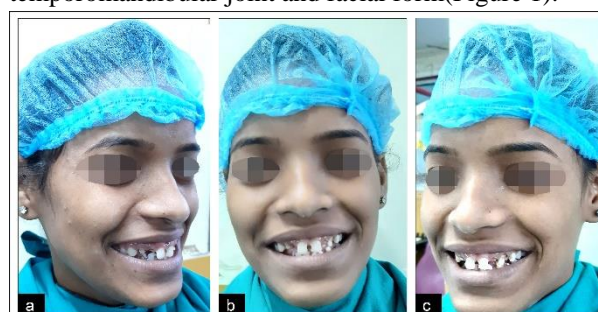
Extra-oral examination revealed normal temporomandibular joint and facial form(Figure 1).

Figure 1: Pre-operative Extra-oral view of the patient: a)Right Lateral, b)Frontal, and, c)Left Lateral

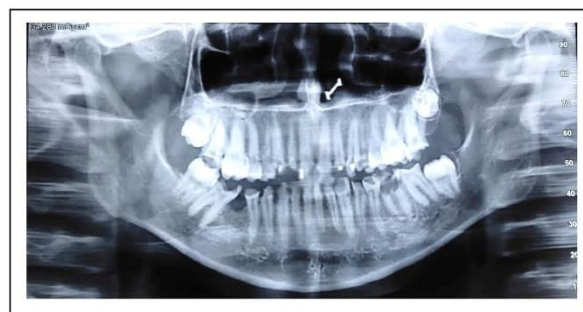
Radiographic examination (Figure 3) revealed that amongst the carious teeth, #12, #12, #22, #23, #35, #34, #33, #32, #31, #41, #42, #43, #44,

and #45 showed a radiolucency approximating the dental pulp, while the remaining showed deep dentinal caries. Additionally, due to severe loss of coronal structure concerning #13, #12, #22, #23, #34, #32, and #31, a post and core restoration was required to support the compromised tooth structure.

Figure 3: Pre-operative Orthopantomogram

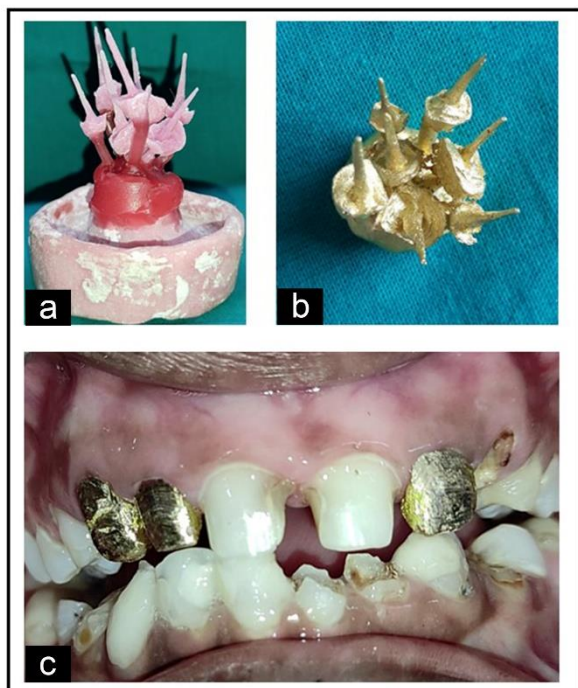
Hence, the pre-prosthetic phase ensued which included extraction of #36 and root canal treatment of #12, #22, #23, #35, #34, #33, #32, #31, #41, #42, #43, #44, and #45 followed by fabrication of a post and core in concerning #13, #12, #22, #23, #34, #32, and #31 (Figure 4a & 4b) and a normal post-endodontic build-up in the remaining tooth. Tooth no. #14, #11, #21, and #24 were restored with composite resin (Tetric-N-Ceram, Ivoclar Vivadent, Schaan, Liechtenstein) after caries removal. Crown lengthening was done using a diode laser (DPI Dental Products, Mumbai, India) at 980 nm concerning the maxillary anterior gingival region to enhance esthetics. The gingiva was allowed to heal over 4 weeks before commencing the post-space preparation.

and an impression was made. The obtained cast metal post and core were then cemented into the respective teeth using a Type I Glass Ionomer cement (GC Gold Label Glass Ionomer Luting and Lining cement, GC Corporation, Tokyo, Japan) for all the teeth commissioned to receive a post and core restoration (Figure 4c). Following this, tooth preparation was done for the teeth in the maxillary arch to receive metallo-ceramic crowns. Impressions were made using the putty wash technique using a soft putty (Aquasil Soft Putty, Dentsply Sirona, USA) and a light body (Aquasil Ultra LV, Dentsply Sirona, USA) impression material. The prepared teeth were provisionalised while the permanent restorations were fabricated in the laboratory and were later cemented with Type I Glass Ionomer Cement (GIC) (GC Gold Label Glass Ionomer Luting and Lining cement, GC Corporation, Tokyo, Japan).

Figure 4: Post and Core a) post and core fabricated by acrylic resin with direct method, b) cast metal post and core, and, c) post and core cemented

In the present case report, a multimodal approach was considered involving restoring the vital teeth affected with caries with composite resin [6], metal post core in a pulpless tooth with severe coronal structure loss, and porcelain fused to metal (PFM) crown[2]. In the current case report, the fabrication of the post and core was done using a direct method using an acrylic resin with an acrylic sprue[7]. The direct method was chosen to curtail the hassle of distortions which are inherent when an indirect method is used to make an impression with elastomers[8]. An acrylic resin was used to fabricate the direct wax pattern instead of an inlay wax to prevent any warpage due to its high coefficient of thermal expansion [9]. Nevertheless, the post-space preparations were smoothed to an optimum to prevent the interlocking of the acrylic resin within the canal walls [10].

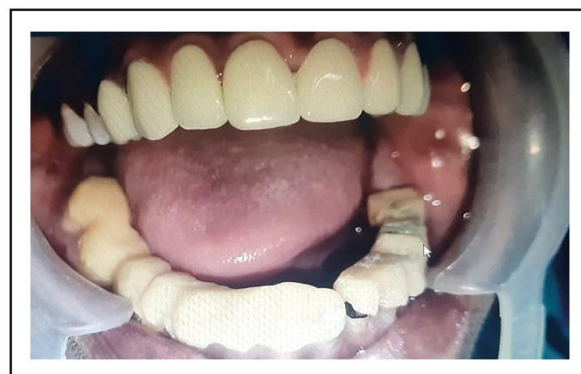
Following this, tooth preparation was carried out for the mandibular arch, putty impressions were made, and provisional crowns and fixed-partial dentures were fabricated and cemented using an indirect method (Figure 5).

Figure 5: Provisional restorations fabricated with acrylic cemented on the mandibular teeth

The provisional restoration was adjusted in the patient's mouth by locating all excursive pathways from the CR to an edge-to-edge relationship for over six weeks. During this period, the patient's condition and functions, such as muscle tenderness, TMJ discomfort, mastication, and speech were evaluated. Improvement in the above parameters confirmed the patient's tolerance to the new mandibular position with the restored VDO. After determining the teeth' contours and form and locating the incisal edges, an elastomeric impression of both the arches was made, casts were prepared and mounted in an articulator using face-bow and inter-occlusal records. The definitive restorations were cemented using a Type I GIC on separate appointments for anterior and posterior segments respectively. Occlusion was verified as being free of any interferences during lateral excursion or anterior protrusion (Figure 6a-6c).

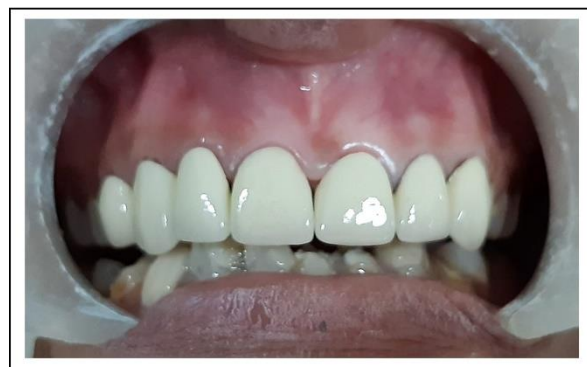
Figure 7 illustrates the final clinical post-operative view with the teeth in occlusion and Figure 8 depicts the post-operative Orthopantomogram. The patient reported being highly satisfied with the final treatment outcome, especially due to an enhancement of her facial esthetics and improved masticatory effectiveness. Figure 9a-9c shows the extra-oral view of the patient.

Figure 7:Post-operative Intra-oral view of the patient in occlusion showing porcelain-fused-to-metal crown cemented

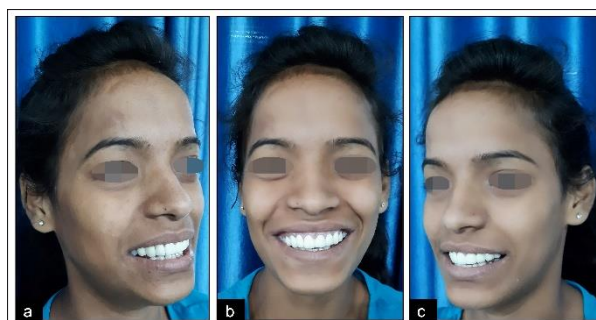
Figure 9: Post-operative Extra-oral view of the patient: a)Right Lateral, b)Frontal, and, c)Left Lateral
