Management of Cohesive and Adhesive Fractures of Porcelain Fused Metal Crowns Using Ceramic Repair Kit : A Case Report

Jobin joy¹,Ragul I¹,Prasad aravind¹,Lino paul²,Harishini S²,Jailaan murshitha²,Peter S²,Shabana²

^{1,2}Department of prosthodontics and crown and bridge, mahe institute of dental sciences and hospital, mahe, india

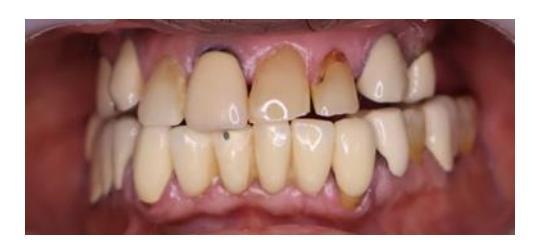
Figure 1: Pre op view showing fracture irt 41

The patient was a known bruxer as well. The treatment regimen and maintenance therapy were explained to the patient. Since both the metal and ceramic layers are fractured, i.e., both cohesive and adhesive fracture it should be treated in an appropriate way.

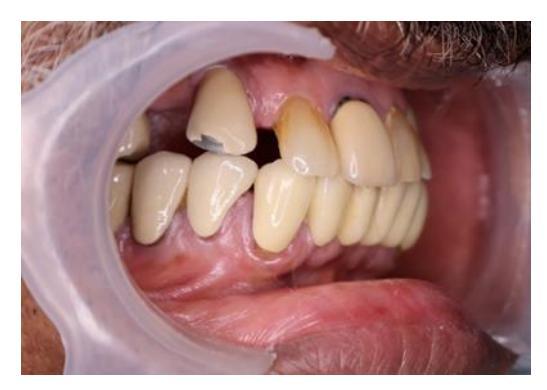
Figure 2: pre op view showing fracture irt 13

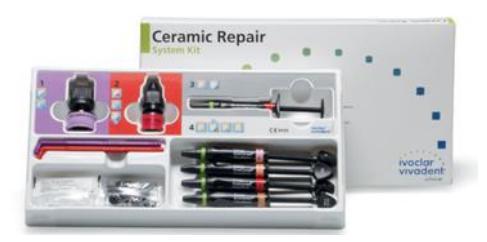
Figure 3 : Ivoclair ceramic repair kit

The Ceramic Repair System Kit consists of the following components:

- 1. Tetric EvoCeram® a light-curing nano-hybrid composite
- 2. IPS Empress Direct® Opaque a light-curing opaquer suitable for masking exposed metal surfaces
- Monobond® Plus a primer designed for establishing an adhesive bond between luting composites and all indirect restorative materials
- 4. Heliobond a light-curing bonding agent.

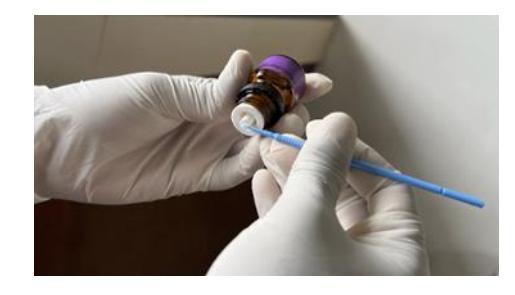
Figure 4 :monobond is carried in applicator tip

- 3. Monobond plus Apply Monobond Plus with a brush to the exposed metal, ceramic, and composite surfaces, then wait 60 seconds for it to react. Then, use oil-free air to dry. (Avoid rinsing with water.)

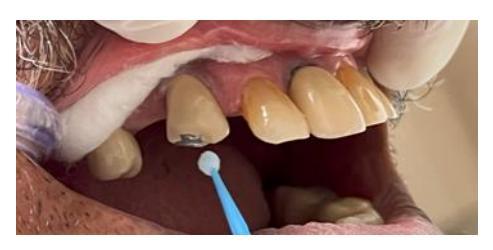
Figure 5: monobond applied in the respective site

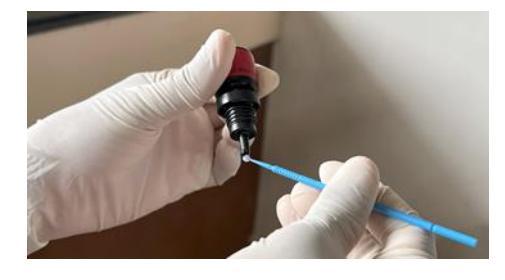
Figure 6: heliobond carried in applicator tip

- 4. Applying Heliobond
- Over the entire surface that needs to be fixed, apply a thin layer of Heliobond. Utilizing compressed air, eliminate any surplus. Then, light-cure for 10 seconds.

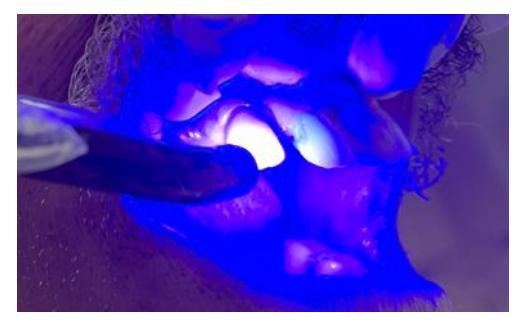
Figure 7: light curing for 10 sec

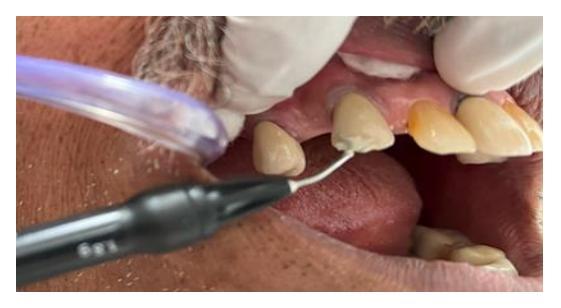
Figure 8:application of opaque to mask the metal

- 5. Applying the opaquerOn the metal surface that has been prepared, only apply IPS Empress Direct Opaque. The maximum thickness of the applied layer should be 0.5 mm.Next, let it light-cure for 20 seconds.

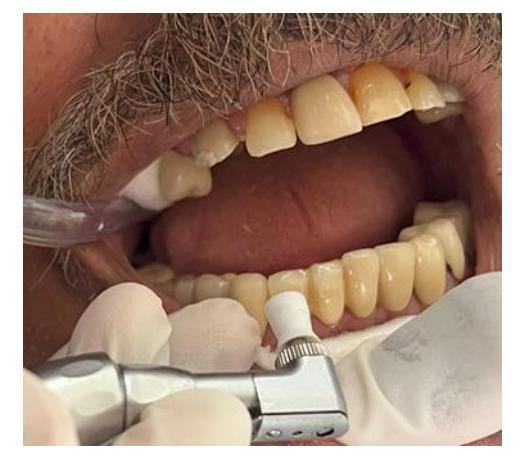
Figure 9 : composite added in increments and cured and finishing and polishing done

- 6. Employing Tetric EvoCeram to restore the restorationUse an appropriate equipment to adjust the material and apply Tetric EvoCeram in maximum 2 mm increments. Light-cure each layer individually for 10 seconds.

- 7. Finishing and polishingUsing an appropriate finegrained diamond grinding tool, remove any excess.

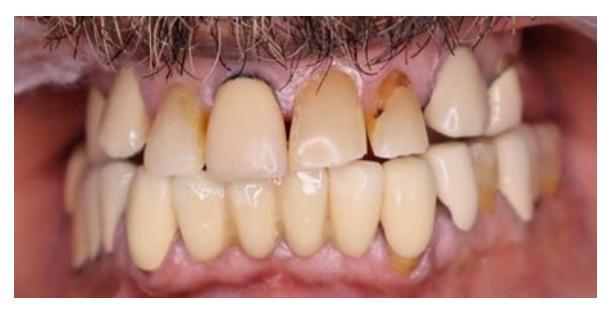
Figure 10 : post op view showing repaired 41

After completion high points were checked and corrected and patient was adviced with 2mm hard splint for the management of bruxism.

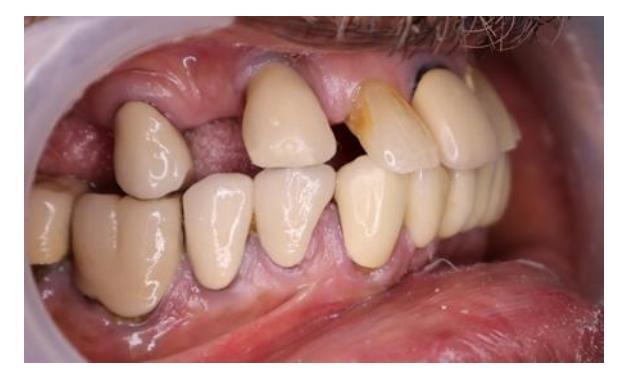
Figure 11 : post op view showing repaired 13
